# **NASA CONTRACTOR REPORT 181965**

## **FRACTOGRAPHY OF COMPOSITE DELAMINATION**

**W. D. Bascom**  
University of Utah  
Salt Lake City, Utah

**July 1990**  
Grant NAG1-705

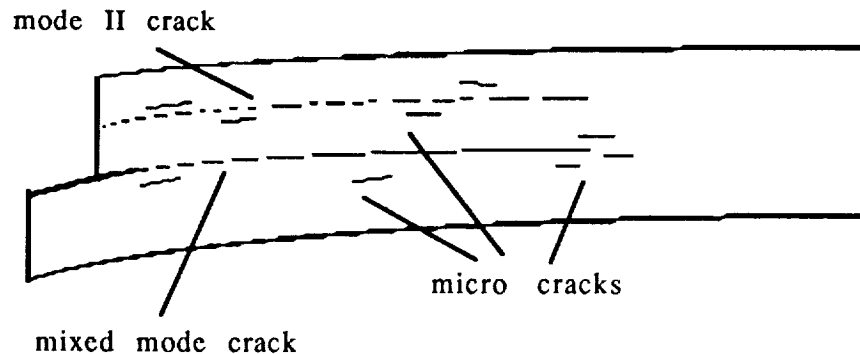
The general appearance of the cut sections is shown in Figure 10. Two major cracks developed in the specimen; the major crack along the central plane and a pure Mode II crack in the upper half of the specimen. The crack in the upper half of the specimen is designated as a "pure" Mode II crack based on the fact that there was relatively little displacement of the crack faces. In principle, a Mode II crack should not be visible since it involves only shear displacements. None the less, the cracks generated in this study are the result of primarily Mode II loads.

Figure 10 - Schematic of cracking in a Mode II specimen

As shown schematically in Figure 10, there were microcracks

near the major crack and especially ahead of the crack front. It was sometimes difficult to distinguish microcracks from laminate imperfections but there is the distinct possibility that "satellite" microcracks develop ahead of the main crack front but then close-up once the crack front has passed. The formation of these satellite cracks probably constitute part of the energy of Mode II crack propagation, at least for the test configuration used here.

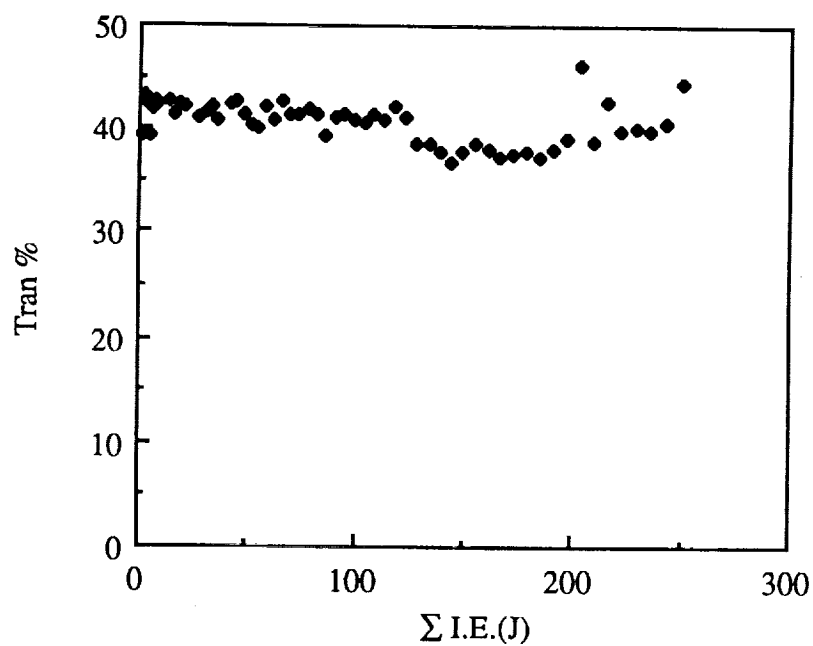
AS4/polycarbonate(+45) laminate: Stiffness and percent transferred energy vs  $\Sigma$ I.E are shown in Fig.49. A C-scan and damage map for  $\Sigma$ I.E of 250J are presented in Figs. 50 and 51 respectively. The reduction in stiffness and the extent of damage were even less than for the (0/90) laminate.

Figure 49B - Percent transferred energy vs cumulative impact energy for AS4/polycarbonate  $(\pm 45)_{16s}$

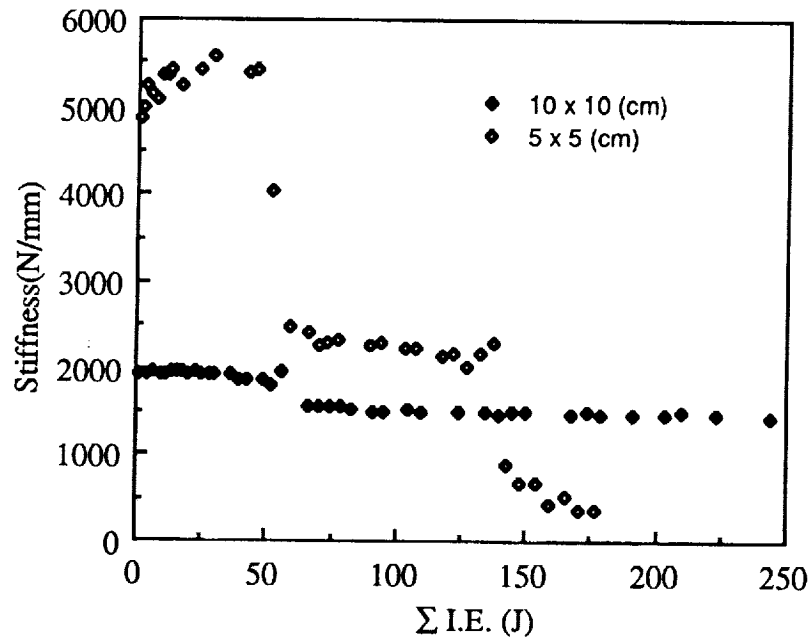
The effect of increasing the sample size for AS4/3501-6 is shown in Fig 51 and for AS4/PEEK in Fig 52. As expected, the 10x10cm specimens had much lower stiffness and the changes in stiffness with cumulative impact energy were less pronounced. In the case of the AS4/3501-6 there was a transition at about the same  $\Sigma$  I. E. as was observed for the smaller, 5x5cm, specimen. In the case of the AS4/PEEK the 10x10cm specimen did not undergo any detectable change in stiffness. In fact, the experiment was

extended to almost 4000 J without any observable change in stiffness.

Figure 51 - Comparison of stiffness vs  $\Sigma$  I. E. for plates of AS4/3401-6, (0/90)<sub>16s</sub> with unsupported dimensions of 5cm x 5cm and 10cm x 10cm.

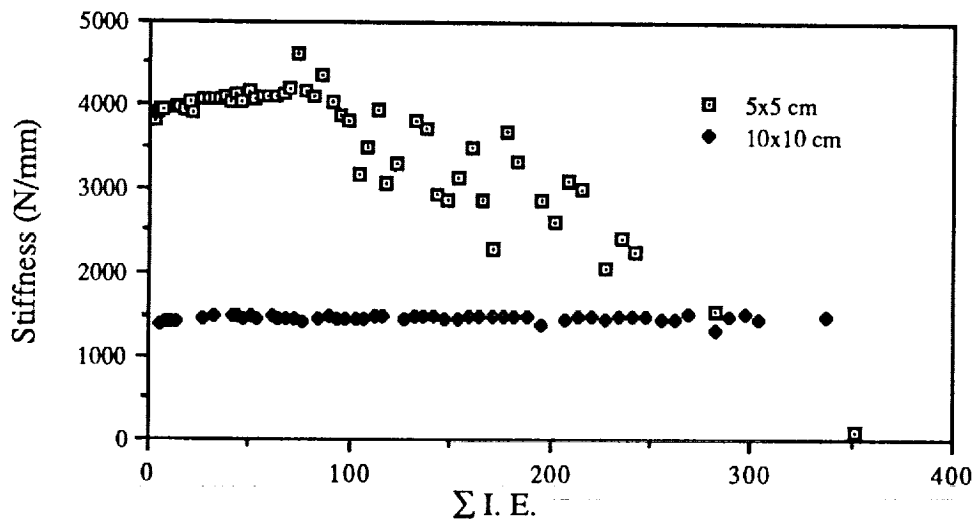
Figure 52 - Comparison of stiffness vs  $\Sigma$  I. E. for plates of AS4/PEEK, (0/90)<sub>16s</sub> with unsupported dimensions of 5cm x 5cm and 10cm x 10cm.

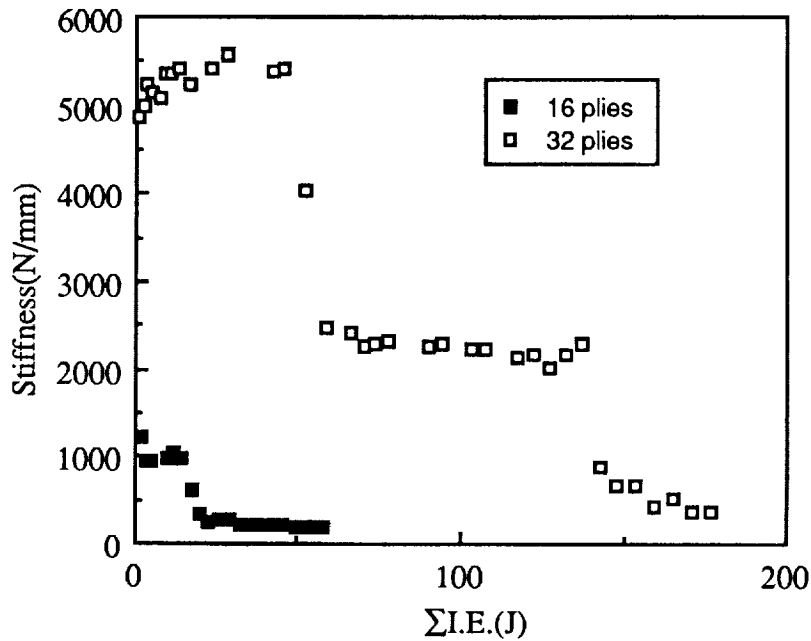
Figure 53 - Comparison of stiffness vs cumulative impact energy for AS4/3501-6 (0/90)<sub>s</sub> laminates having 16 plies and 32 plies

Decreasing the AS4/3501-6 specimen thickness from 32 plies to 16 plies caused the initial change in stiffness to occur at a  $\Sigma$  I. E. of about 5 J. Subsequently, there was a short plateau in stiffness (second stage) followed by a transition to a lower stiffness (third stage). Evidently, reducing the specimen thickness results in the same sequence of damage modes but over a much shorter range of cumulative impact energy than for the thicker, 32 ply specimen.

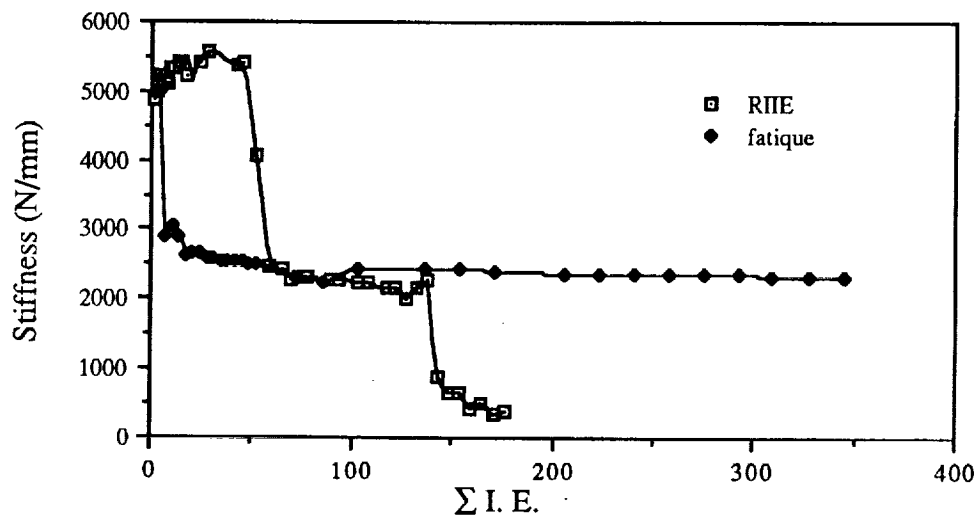
Fatigue Testing vs RIIE Testing: Specimens of AS4/3501-6 were tested in a "fatigue" mode in which the specimen was impacted repetitively but at a constant impact load. The results of these tests are compared with the repetitive impact with increasing load (RIIE) in Fig 55. In the fatigue test, the stiffness dropped after the first impact to the second stage level of the RIIE test but then remained constant with further loading.

Figure 55 - Comparison of the change in stiffness vs cumulative impact energy for fatigue loading vs repetitive impact with increasing energy (RIIE) for AS4/3501-6(0/90)<sub>16s</sub>.

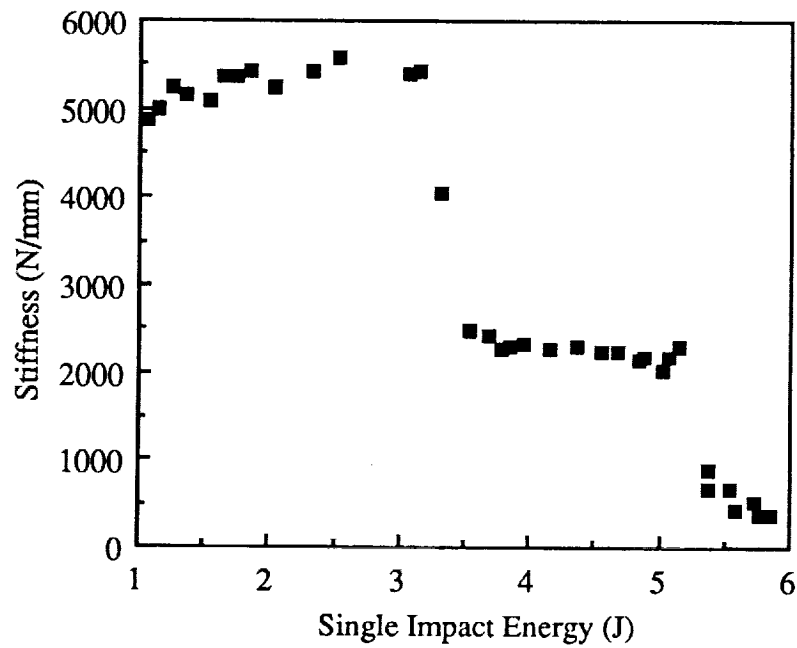
These data can be viewed from a different perspective by plotting the change in stiffness with actual impact energy rather than with cumulative impact energy. The data plotted in Fig. 56 are from the RIIIE testing and the data plotted in Fig. 57 are from the fatigue testing. A comparison of Figs. 56 and 57 show that the loss in stiffness occurs at about 3 J whether this level of energy is arrived by incrementally increasing the impact load (RIIE test) or is the initial load in the fatigue test.

Figure 56 - Stiffness vs impact energy (noncumulative) from RIIE data for AS4/3501-6, (0/90)<sub>16s</sub> (Fig. 18)

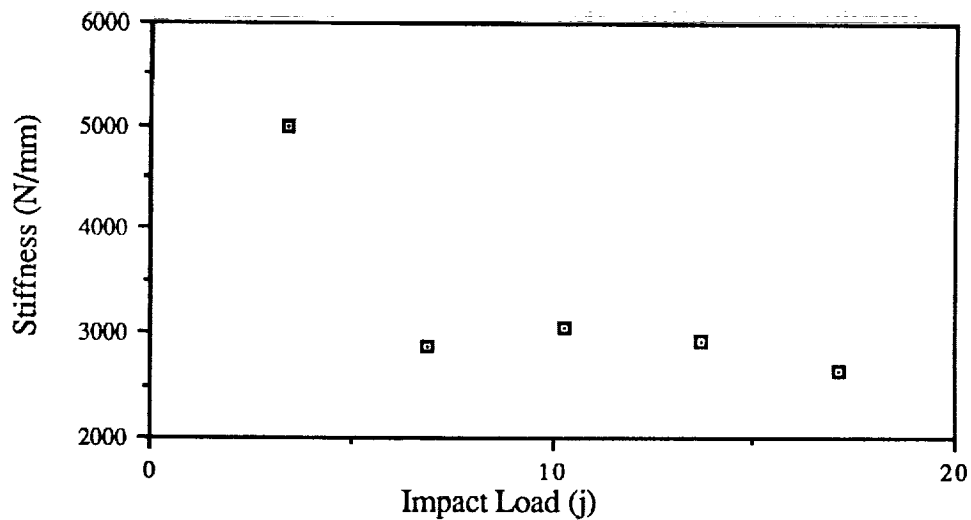
Figure 57 - Stiffness vs impact energy (noncumulative) from fatigue tests for AS4/3501-6, (0/90)<sub>16s</sub>.

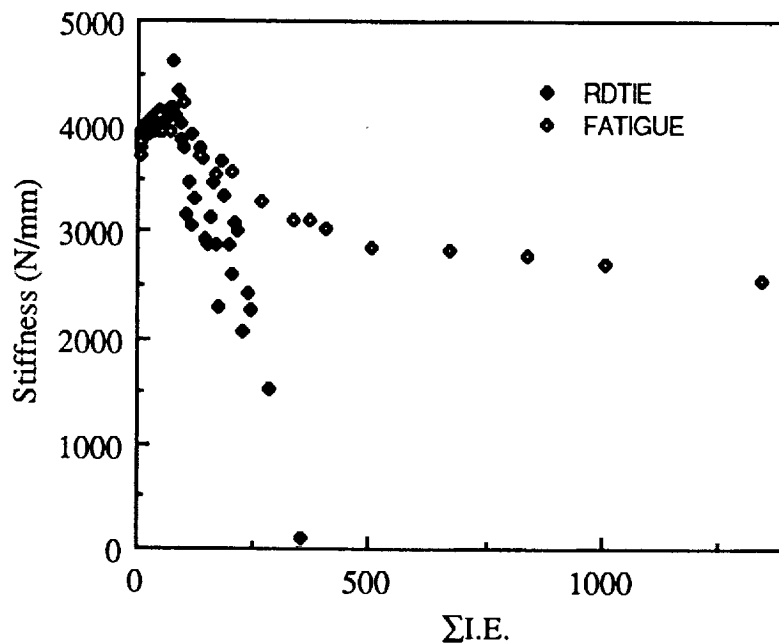
Figure 58 shows the fatigue data vs the RIIIE data for AS4/PEEK (90/0)<sub>16s</sub>. In the fatigue test, even after 1200(J), the stiffness did not drop significantly compared to the RIIIE data. However, the initial decline in fatigue stiffness was relatively gradual compared to the AS4/3501-6 fatigue data (Fig. 55)

Figure 58 - Comparison of the change in stiffness vs cumulative impact energy for fatigue loading vs repetitive impact with increasing energy (RIIE) for AS4/PEEK(0.90)<sub>16s</sub>

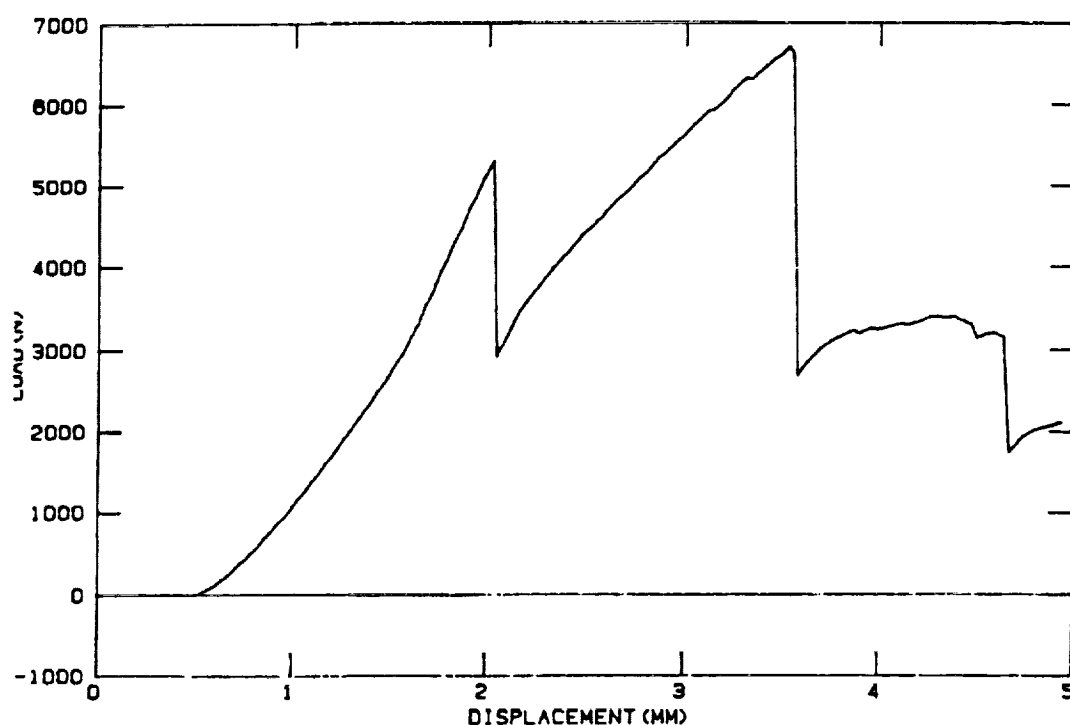
AS4/3501-6 Three distinct regions were observed in the static load displacement plot (Fig.59). In the first region, the stiffness was 5000 N/mm, which was similar to the stiffness (max load/max deflection) in the dynamic test (Fig 18). This stiffness abruptly decreased to 2300 N/mm, which was approximately the same as the stiffness of the second region in Fig 18. The third stage stiffness was 500 N/mm.

Figure 59 - Static force-displacement plot for AS4/3501-6,  $(0/90)_{16s}$

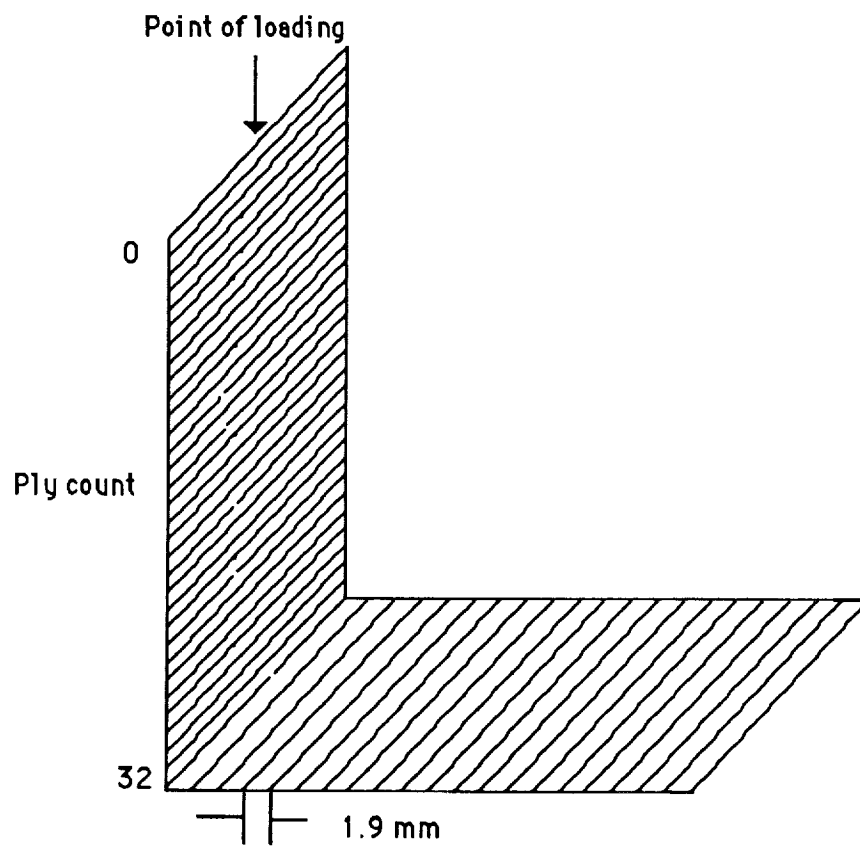
The damage patterns from C-scans were similar to those of the dynamic test (compare Fig. 59 with Fig. 21). Damage maps of each of the stages from the static test are presented in Figs. 60-62. In the first damage stage of the static test, there was no contact damage on the front surface. In the second stage of this test, the pattern of damage was the same as that for dynamic loading, i.e., through the thickness and consisting of transverse cracking and delamination .

Figure 60 - Damage map of AS4/3501-6,(90/0)<sub>16s</sub> laminate loaded to a displacement of ~1.5mm

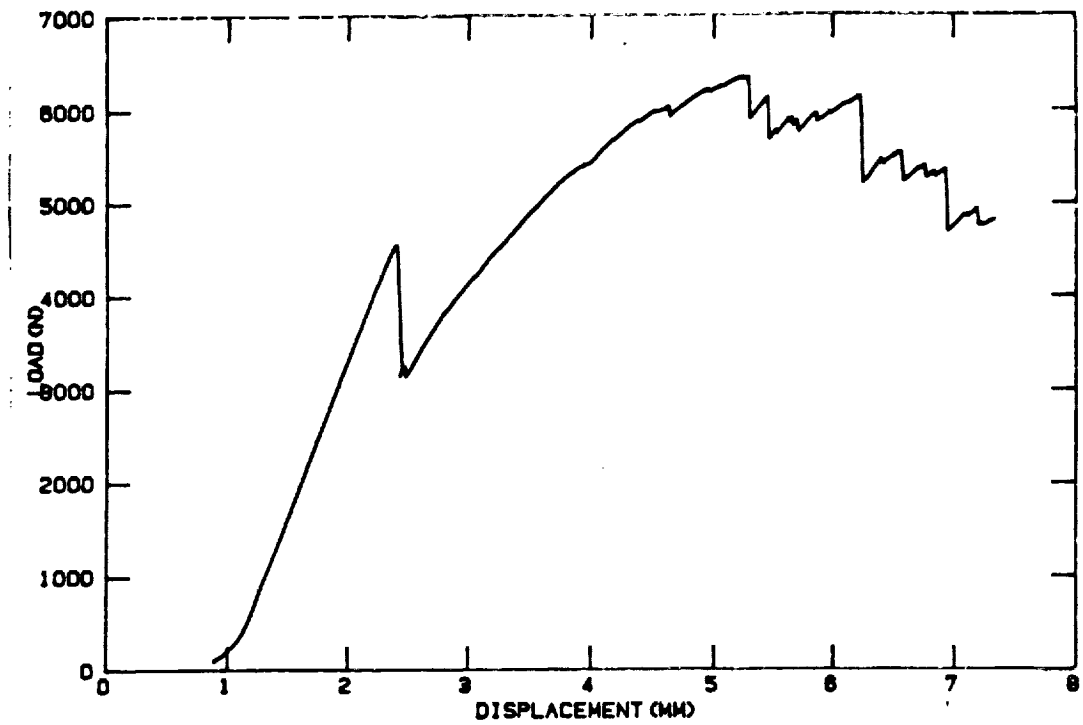
Figure 64 is the static force-displacement curve for AS4/3501-6,(±45) in the static test. The stiffness of the first region was around 3300 N/mm which was the same as the stiffness of the first region in the dynamic tests. Subsequently, the stiffness was about 1700 N/mm until the displacement reached 5 mm at which point the force started to drop until 7.5 mm and C-scanning indicated that the damage had reached the specimen edges.

Figure 64 - Static load-displacement plot for AS4/3501-6 (0/90)<sub>16s</sub>

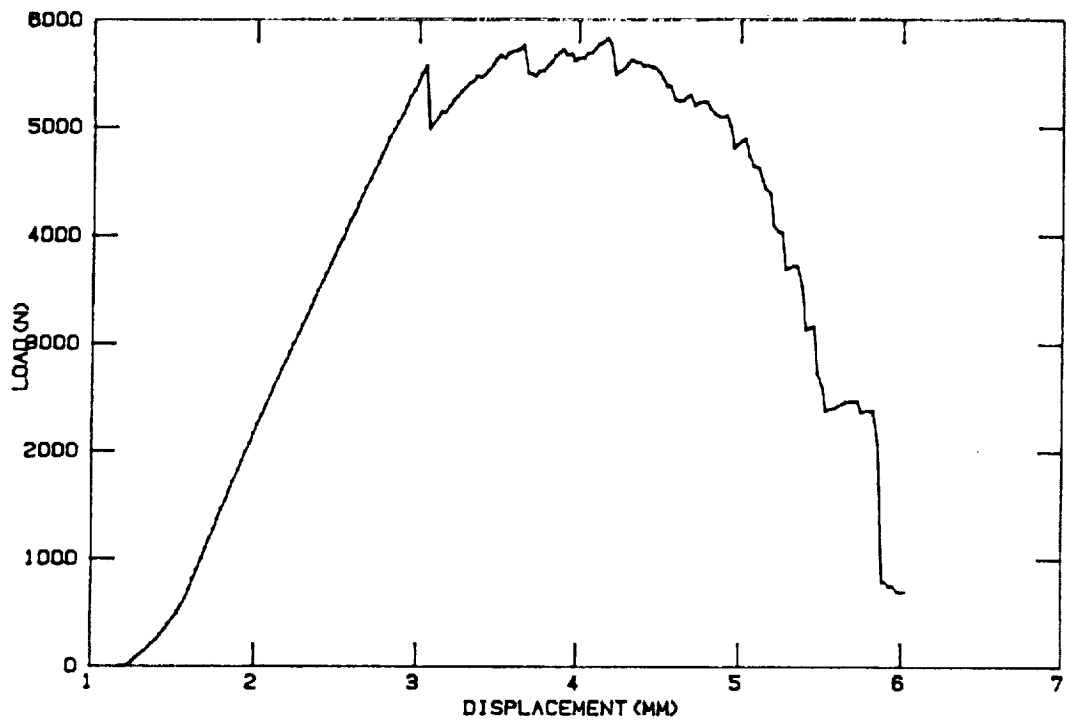
AS4/PEEK: Figure 65 is the load displacement plot for AS4/PEEK (0/90)<sub>16s</sub>. There is an initial constant stiffness followed by a more or less continuous decrease in stiffness that becomes very pronounced after 4.5 mm. The shape of the plot in Fig.65 is clearly different from that for AS4/3501-6,(0/90), see Fig.59. Damage maps at three positions along this load-displacement curve were constructed (Figs. 66-68).

Figure 65 - Static load displacement curve for AS4/PEEK (0/90)<sub>16s</sub>

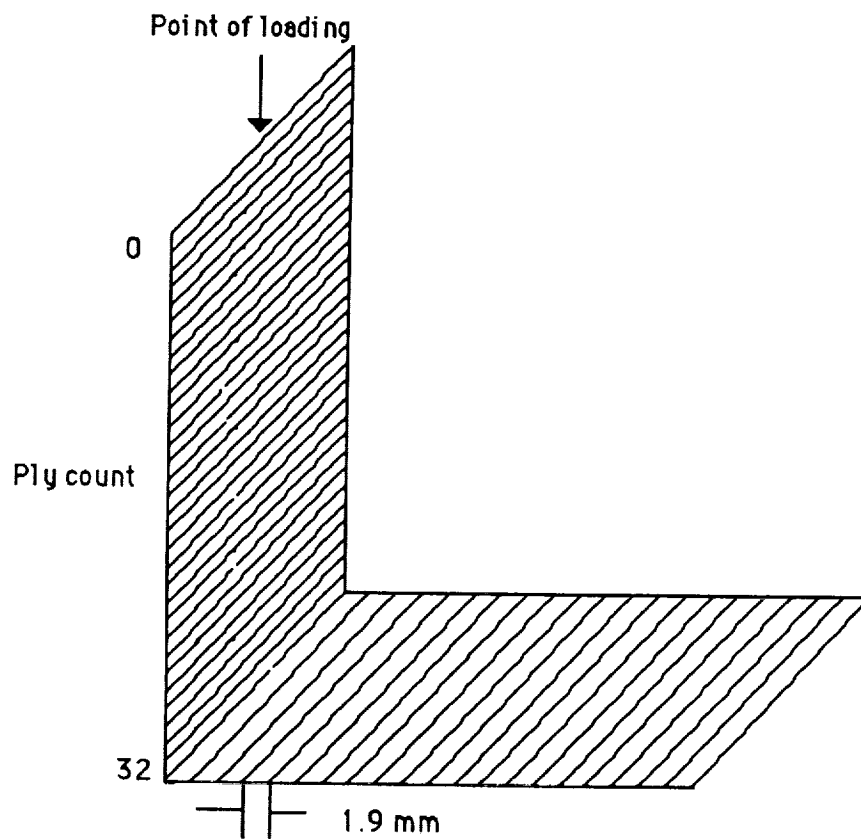
Figure 66 - Damage map for an AS4/PEEK,(90/0)<sub>16s</sub> laminate loaded to about 2.5mm displacement

No damage was found in the first linear region of the static test (Fig. 66). The second damage map (Fig.67) was drawn after the initial drop in force and showed transverse cracking near the front and back surfaces. In addition there was a noticeable bulge in the back surface of the specimen. This type of deformation had not been observed for any of the 3501-6 laminates.

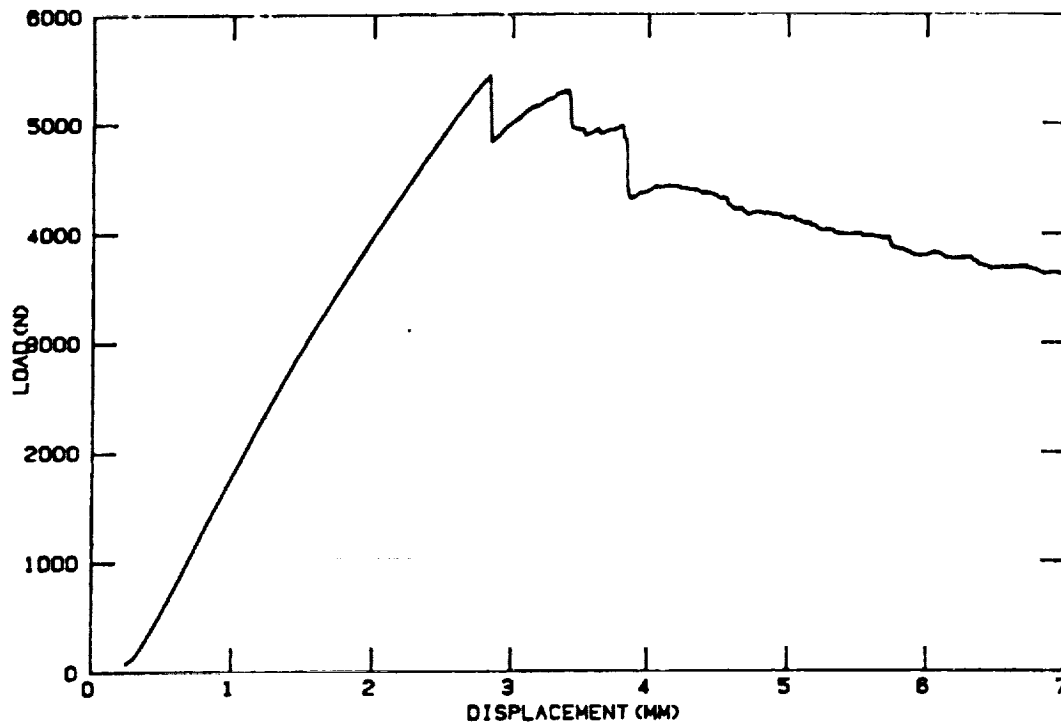
Figure 70 is the static load - displacement plot for AS4/PEEK, ( $\pm 45$ )<sub>16s</sub>. The stiffness of the first linear region was ~2200 N/mm which was less than the stiffness observed in the dynamic test (~3000 N/mm, Fig 43A). After the initial drop in load, the force decreased continuously. The damage was still inside the sample even at 7mm displacement (Fig.71).

Figure 70 - Static load-displacement plot for AS4/PEEK ( $\pm 45$ )<sub>16s</sub>

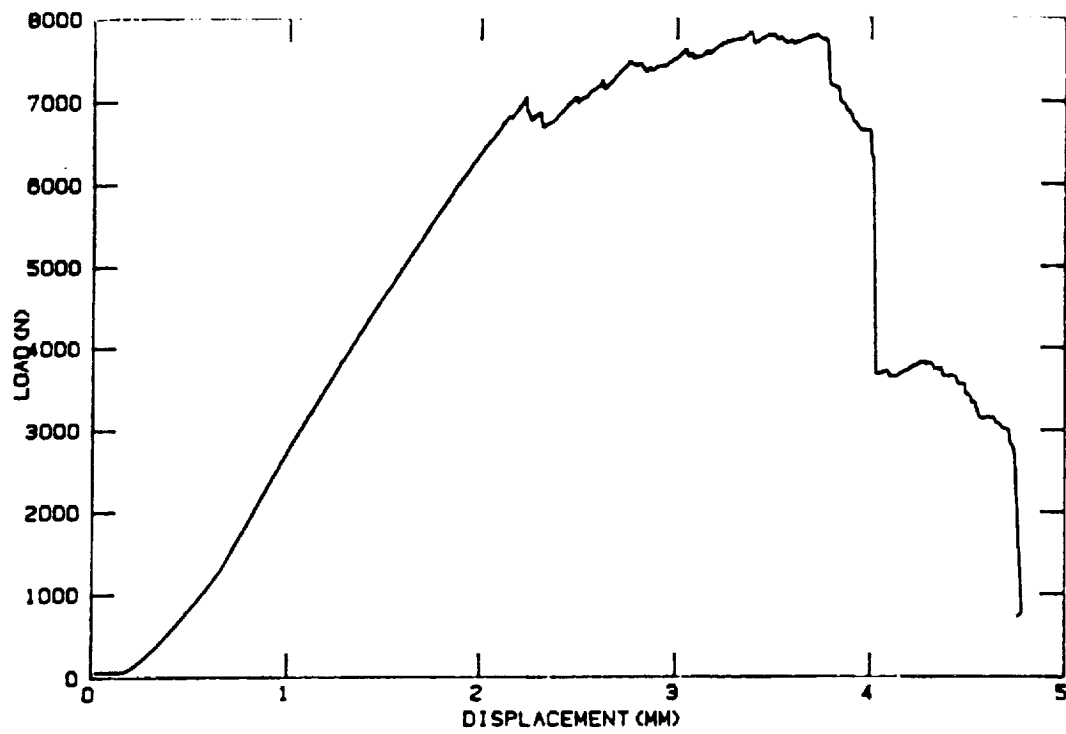
Figure 72 is the static load-displacement plot for the AS4/polycarbonate(0/90)<sub>16s</sub> laminate. At first the slope is linear up to 2.3 mm and then decreased at 3.8 mm displacement and again at 4mm. The constant slope in the linear region indicated a stiffness of ~3700 N/mm, which was less than the ~5300 N/mm observed in the impact tests (Fig. 46A). From C-scans, the sudden drop in force at 4 mm corresponds to the damage reaching one edge of the sample (Figs 73 and 74).

Figure 72 - Static load-displacement plot for AS4/polycarbonate(0/90)<sub>16s</sub>

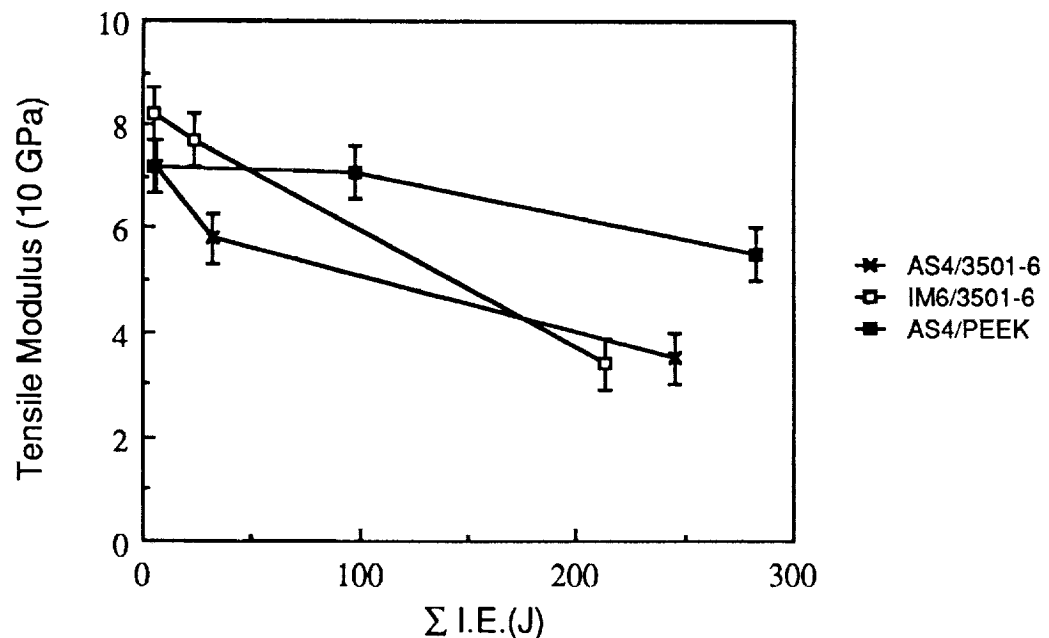
Three impacted samples were selected from the AS4/3501-6, IM6/3501-6 and the AS4/PEEK dynamic RIIE studies and tested for residual tensile modulus (Fig. 75). All specimens were (0/90)<sub>16s</sub> orientation. The test specimens were selected from the high,

For the brittle 3501-6 matrix laminates, the tensile moduli decreased continuously with increasing  $\Sigma$  I. E.. For the tough PEEK matrix, the modulus did not decrease significantly below a cumulative energy of about 100J. At the lower  $\Sigma$  I. E. the IM6/3501-6 had a higher modulus than the AS4/3501-6 due to the higher modulus of the IM6 fiber. At  $\Sigma$  I. E. greater than 200J, the the moduli of the two 3501-6 laminates were essentially the same suggesting that the damage was so severe that it was essentially determined by the matrix, i.e., the fibers were severely broken and unable to carry load. On the other hand, the AS4/PEEK still had a high modulus even at  $\Sigma$  I. E. of 275J due presumably to the relatively small area of damage even though there had been considerable fiber fracture.

Figure 75 -Residual tensile modulus vs cumulative impact energy

The post-impact tensile modulus results (Fig. 75) are at first glance somewhat surprising. One would have thought that delamination and transverse cracking, that dominate the 3501-6 laminates would be less severe on tensile stiffness than the fiber breakage sustained by the PEEK laminate. In fact, the PEEK laminate

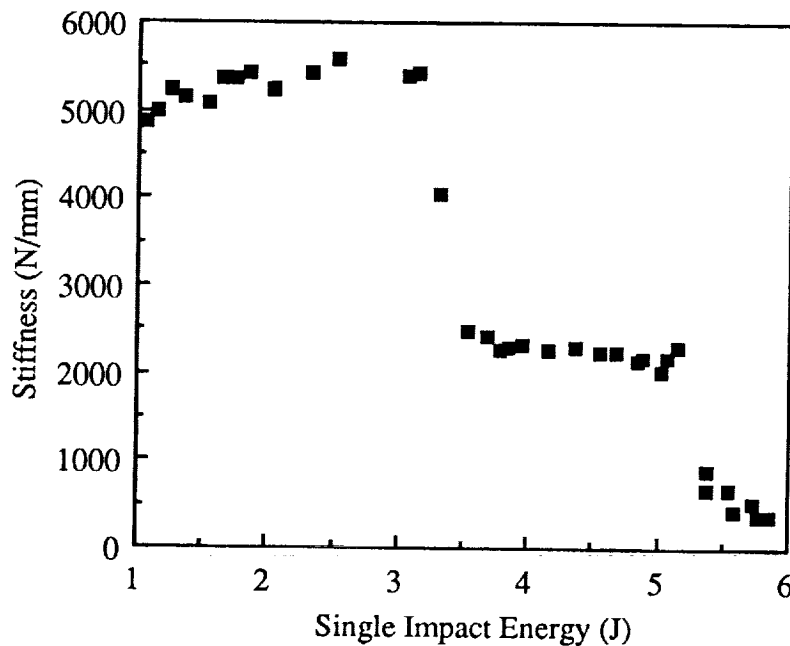
Continuing the fatigue test at 3J for each impact resulted in no further change in stiffness. On the other hand, in the continuation of the RIIE test, a second change in stiffness occurred at about 5J (Figure 76). The fact that through the second stage the stiffness is relatively constant suggests that whatever damage is occurring, it is not sufficient to alter the plate stiffness. None of less, damage is occurring as evidenced by the increase in transferred energy. The fact that the transferred energy varies considerably from one impact to the next, suggests that the amount of microdamage that occurs for a given impact varies considerably. One impact may result in only a minor amount of cracking but creates a condition that precipitates more extensive damage during the next impact event.

Figure 76 - Stiffness vs single impact energy for AS4/3501-6

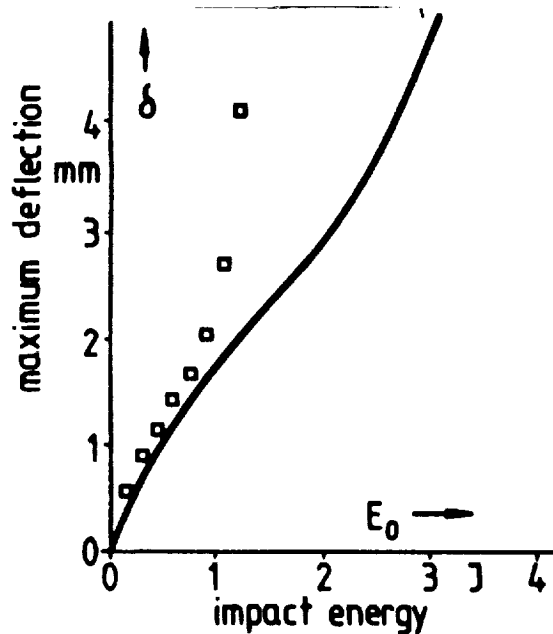
A comparison of the RIIIE testing results with those from single impact drop tests is shown in Fig.77 taken from reference 18. Both methods display similar information but the RIIIE results are compressed along the impact energy axes. This result is reasonable in that in the RIIIE test the damage accumulates in the sample, i.e. less impact energy is required to see the next damage stage than for the single impact test. Therefore, the RIIIE technique reduces the experimental time and materials required to investigate impact resistance.

Figure 78 - Comparison of repetitive impact with increasing energy vs single drop testing (reference 18)
